**DEPARTMENT OF COMMUNITY PLANNING
AND ECONOMIC DEVELOPMENT**
STORMWATER UTILITY

MEMORANDUM

SUBJECT: Reasonable Use Exception – Geotechnical Documents Review for 9020 Baird Rd NE (TC Project # 2019100758) – Manke

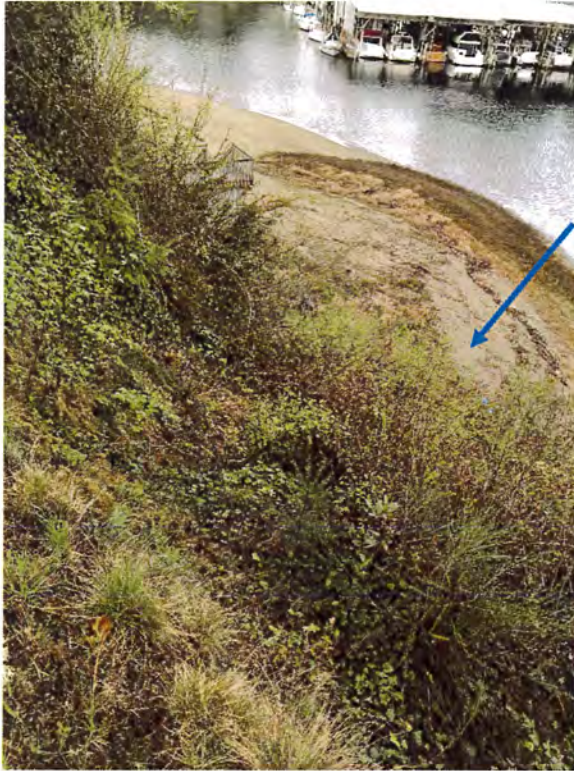
There is clear evidence that the steep marine bluff is actively eroding due to surface water (stormwater) runoff down the face of the bluff. The beach below the marine bluff does not appear to be chronically impacted by tidal action but likely experiences intermittent tidal erosion during extreme high tides or winter storms approaching from the north. This is a confirmation of elements in the GeoResources report. A well-developed beach with vegetation exists below the bluff supporting this observation (see photo #1).

Photo #1 – Beach from the top of the Bluff. Occasional high tide or winter storms may directly impact the base of the bluff but active erosion from the toe does not appear to be the predominant cause of bluff erosion. Established vegetation is observed at the base of the bluff.

- Placing woody debris, similar to what is currently located at the toe of the marine bluffs, may help prevent erosion that occurs when extreme high tides or winter storms occasionally impact the toe of the bluff.

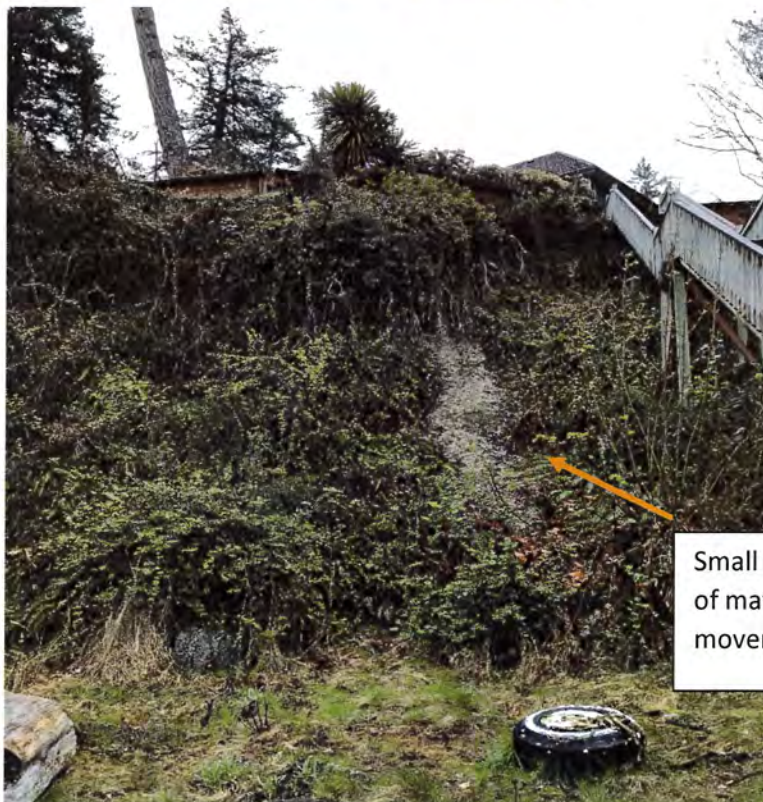
There is evidence of smaller soil failures occurring via a debris flow process indicating saturation of the soils at the bluff face under the influence of gravity. Some larger shallow slides are also evident along the bluff indicating that instability occasionally exists further back into the slope (See photo#2). This is likely caused by near surface ground water or stormwater saturating the bluff near the top of the slope. This was identified in the GeoResource report and fits with the evidence seen during the site visit.

Photo #2 – Small, recent debris flow originating near the top of the marine bluff.

Small debris flow indicates saturation of materials resulting fluid-like mass movement.

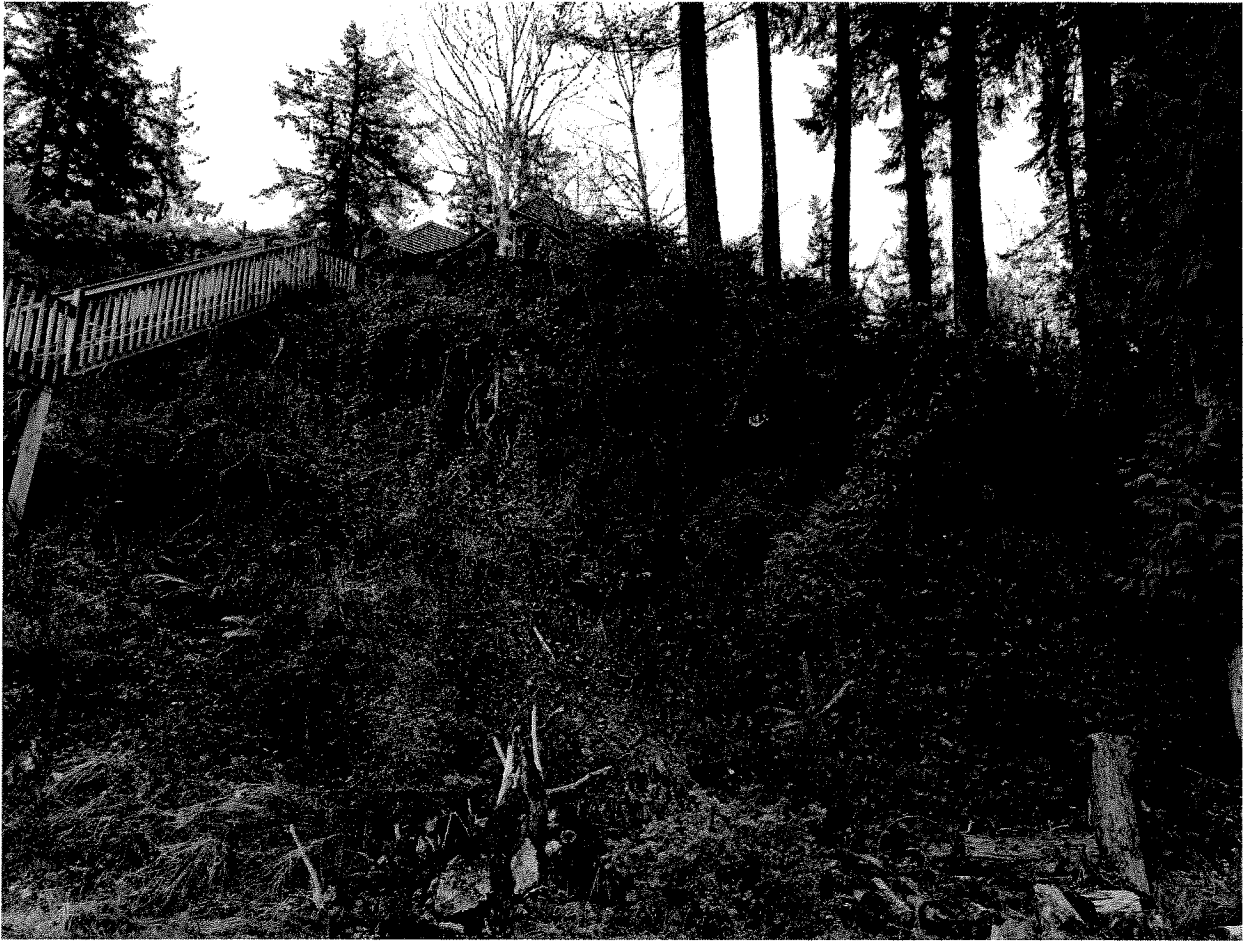
- The bluffs surround the peninsula upon which the house is situated. The slopes facing west toward the water are near vertical and have numerous scars from recent and historic sloughing events (See photo #3). As stated earlier these events are small to intermediate in size and appear to be generated from the top of the bluff and *not* from constant wave action undercutting the toe of the slope.
- The slopes on the eastern portion of the site appear are less steep than the marine-facing bluffs. This part of the property is influenced more by a small stream and associated drainages than tidal/marine action. Slopes in this area are steep, however signs of instability are lacking. Large, old-growth timber is located undisturbed on the slope.

Photo #3 – West-facing Marine Bluff showing some of the historic slope failures on the order of a few yards to ten yards or more. Woody debris is seen at the top of the slope.
