# Margenex International

## FIELD REPORT

**DATE:** April 7, 2009 1355-1417 PDT  
**PROJECT:** North Totten Inlet Mussel Farm EIS  
**SITE:** Taylor Shellfish “Old Plant” site  
**ADDRESS:** 8033 Hargis St NW  
Shelton, WA 98221

**Objectives:** Characterize and photograph beach where new mussel farm float frames will be assembled and launched.

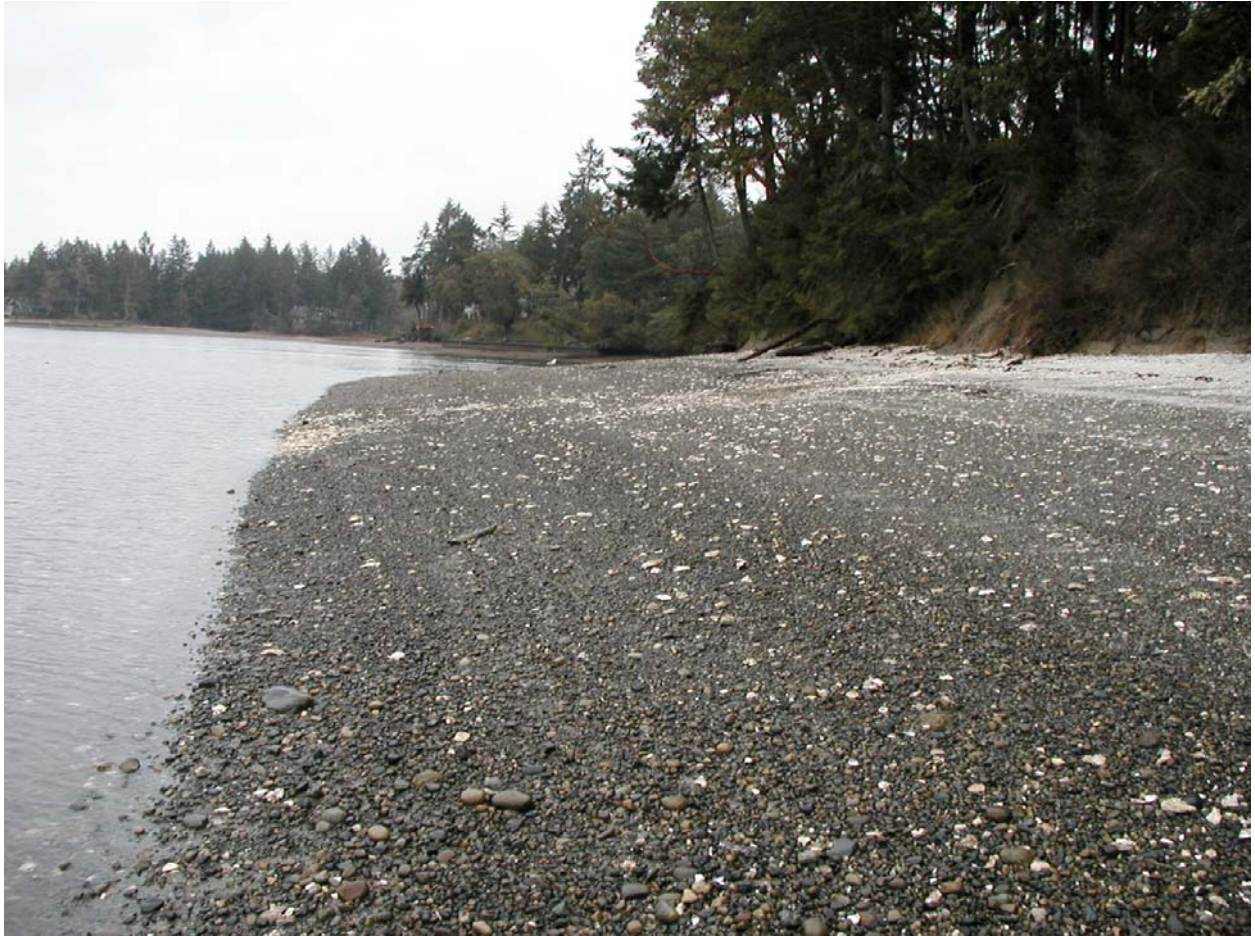
**Figure 2. Substrate of the Work Area.**

Observations: I was accompanied to beach at the “Old Plant” site on March 19, 2009 by Taylor staff Antonio Franco and Evan Sanate. The beach was characterized as moderate slope, semi-protected beach at the base of a steep bluff. Substrate consisted of large gravel with a few cobbles in the mid-tidal zone with smaller gravel, sand, and heavy oyster shell hash in the upper intertidal to the toe of the embankment. According to the WDFW PHS Database, the beach is not documented for rock sole, surf smelt or Pacific sandlance spawning, nor as potential spawning habitat for those species. Pacific herring, however, are documented to spawn in subtidal waters off this reach of beach (near the entrance to Gallagher Cove).
